# Recovering Performance Loss Due to Air Binding

## – A Case Study –

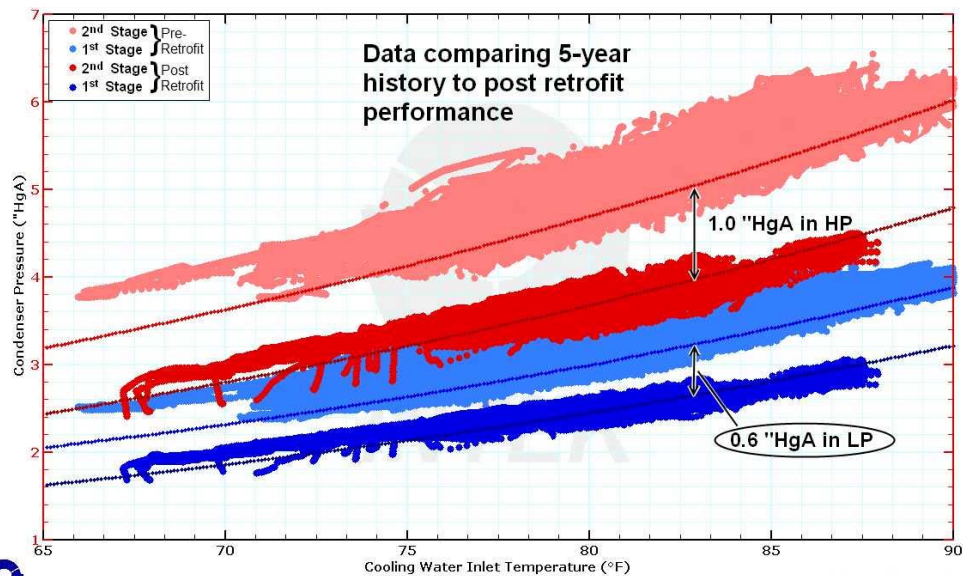
The first objective of the engineering study phase was to determine the magnitude of low condenser performance and also identify the root causes for the specific degradation mechanisms. The results of the initial study verified that the ball cleaning system was maintaining clean tube conditions and that air binding, despite low air in-leakage, was the overwhelming cause for the measured poor performance. Following the engineering study a proposal was accepted to alter the steam, condensate and noncondensable flows by installing a steam side condenser retrofit concurrent with the condenser retube. A comparison of the measured condenser pressures (5 minute averages) before (5 years prior) and after the condenser retrofit for the same condenser duty range is plotted in the figure below.
